# Ideal Inspection

# INSPECTION REPORT

Client: K&S Power Tongs	Location: DaPaJo Construction Limited	Date: May 10, 2013
P.O. :	Work Order : 2248a	Report : 3834
Page : 1 of 1	Unit : KS 902	S/N: 080490435
Inspection: Magnetic Particle		
Parts Examined: AOT 9 5/8" 65 Ton Side Door Casing Elevator		
Surface Condition: Painted	Material Temperature: 10° Celsius	
Procedure: MPI-DPJ-001	Code: ASME Section V, ASTM E709	
Equipment: Parker B 310 Contour Probe		
Method: Magnetic Particle, AC Continuous, Wet Florescent Method		
Test Medium: Magnaglow 14 HF Florescent Prepared Bath

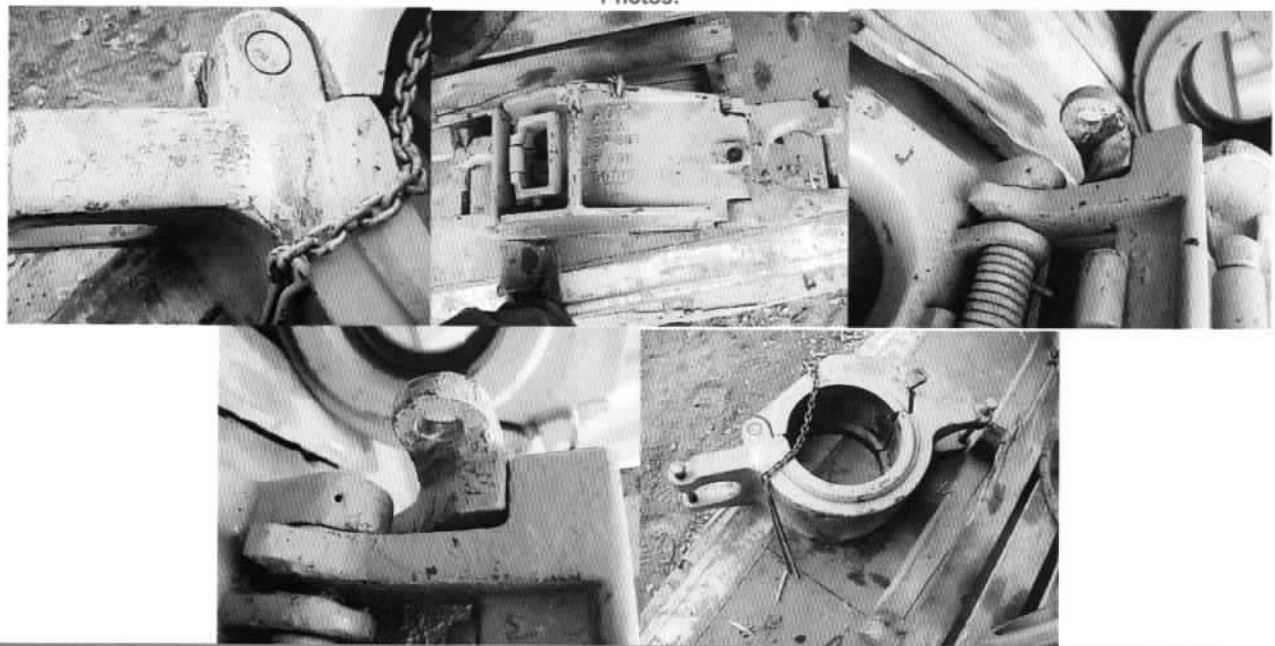
Photos:

Crack found on safety pin ear (crack was repaired and the part is ready for service).

After repair was completed no defects were found at the time of this inspection.

Repair was performed by Geoff Warren a CWB certified journeyman welder employed by Dapajo Construction Ltd.
